GREAT BROOK FISH PASSAGE RESTORATION PROJECT PLAINFIELD, VERMONT

MMI #3846-03

January 4, 2011

Prepared by:
Milone & MacBroom, Inc.
South Burlington, Vermont

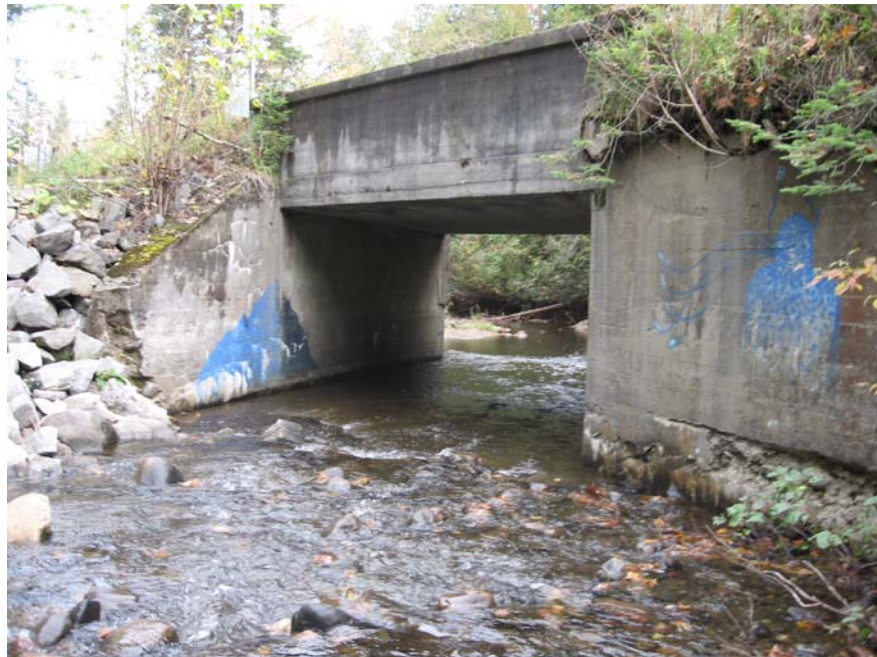
Upstream Face

Culvert #1 at the upstream end of the project (ID 2361, elevation 1,300 feet) had a perched outlet with a downstream plunge pool (Appendix A). The channel makes a sharp bend to the right as it enters the upstream side of the culvert. The left bank is armored with riprap to reduce erosion near the structure. This culvert has some serious structural deficiencies including cracking and dislocated concrete on the right downstream wingwall and the downstream concrete apron. The structure appears to be controlling the grade of the channel as the degree of channel incision appears to be a bit higher on the downstream side of the structure.

Design plans were drafted for each culvert including details of the design elements (Appendix J). The design for culvert #1 (upper) included increasing the tailwater control by two feet using a rock weir, roughening the channel with random boulders for 50 feet downstream of the weir, selectively placing boulders at a designated cross section to increase depth, and placing stone at the undermined outlet of the structure. The weir is the primary tailwater control. The boulders roughen the channel and increase tailwater control a small amount and also allow resting locations for fish moving upstream to the weir and culvert. Great Brook contains many falls and nearby boulders that fish naturally use to rest before or after passing challenging areas. The stone fill at the boulder cross section allows a stepped profile approaching the culvert. The fill under the structure was required to stabilize the undermined apron. This element will increase the operational life of the structure.

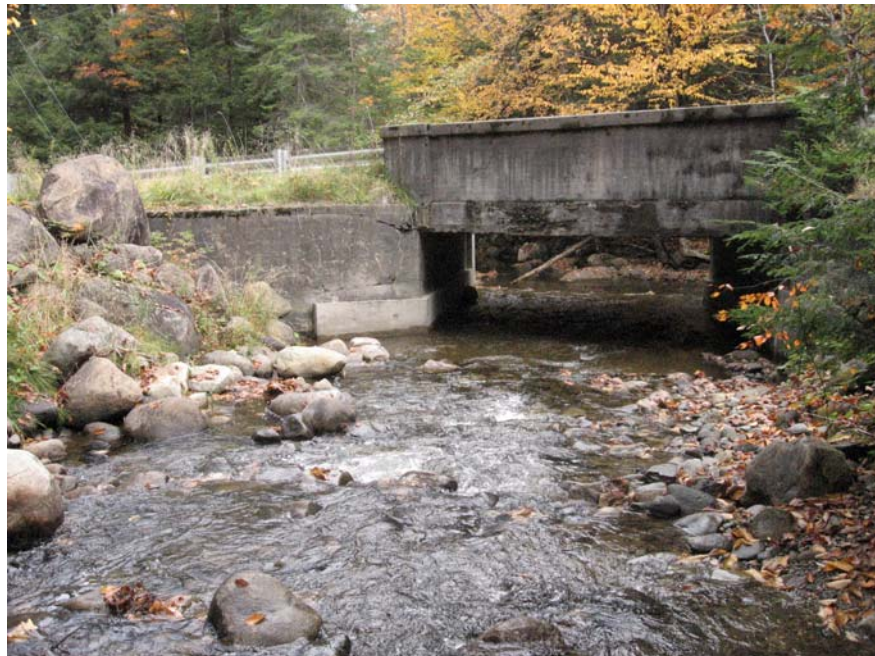
Upstream Face

Culvert #2 (ID 2375, elevation 1,240 feet) had a downstream standing wave indicative of a submerged outlet drop and a plunge pool (Appendix B). Wingwalls at 45 degrees guide water in and out of the structure. Riprap is located on the outside bend as the channel approaches the structure on the upstream side. A small tributary joins Great Brook on the right bank immediately downstream of the structure. The structure appears to be in good condition.

The design for culvert #2 (middle) included a stone weir that is 1.5 feet tall, roughening the channel with random boulders for 50 feet downstream of the weir, selectively placing boulders at a designated cross section to increase depth, and placing stone at the undermined outlet of the structure. The weir was located approximately 100 feet downstream, where the natural tailwater control existed.

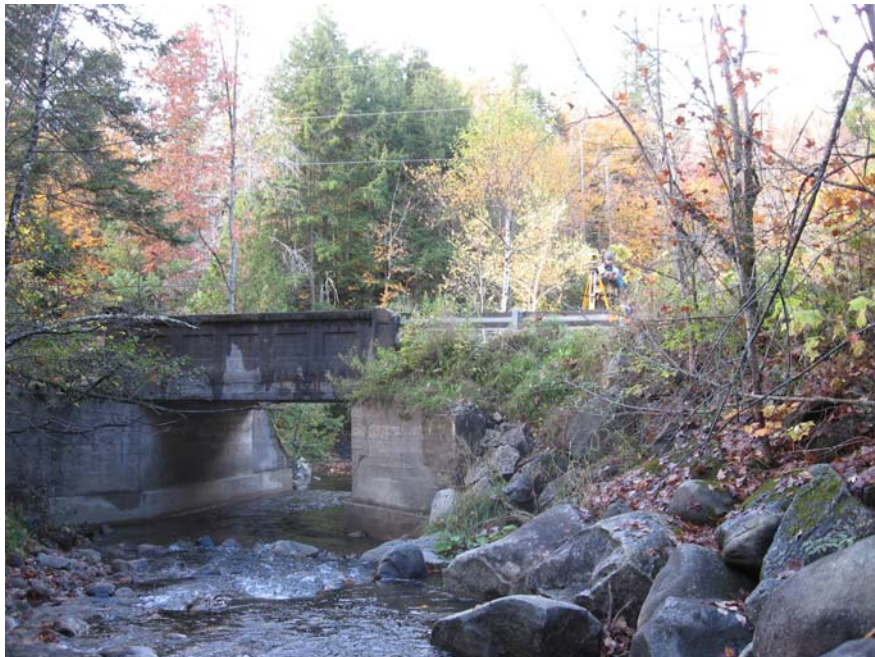
Upstream Face

Culvert #3 (ID 2381, elevation 1,220 feet) located at the downstream end of the project site had an outlet drop associated with the concrete bottom of the box culvert with a downstream plunge pool (Appendix C). The banks were armored with riprap downstream of the structure as the brook flows next to a house before making a bend right along a natural wall of bedrock outcrop. The channel appeared a bit more incised on the downstream side of the structure than upstream, which is common for perched and undersized concrete structures that can act as grade control. Wingwalls at approximately 45 degrees direct flow into the structure, and wingwalls parallel to the flow guide flow out of the structure. The box culvert did not appear to have serious structural deficiencies.

The design for culvert #3 (lower) included a two-foot tall stone weir, roughening the channel with random boulders for 60 feet downstream of the weir, selectively placing boulders at a designated cross section to increase depth, and placing stone at the undermined outlet of the structure. As design progressed, a HEC-RAS model was created for culvert #3 to confirm that floodwaters would not reach the nearby house located on the right bank approximately 50 feet downstream of the culvert. This increased level of analysis was only utilized for culvert #3 where there was potential interaction with human infrastructure other than Brook Road. The modeling generally confirmed the hydraulic results from the FishXing model that capacity remained consistent in the channel and structure for existing and proposed conditions.

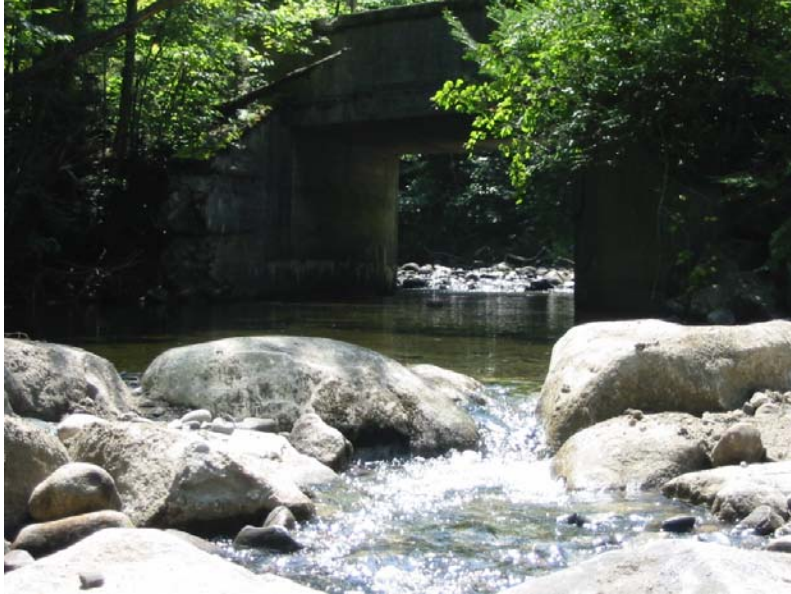
Photograph looking upstream over the rock weir with a fish passage channel and the backwatered Culvert #1 (Upper) taken on August 13, 2010 during low flow.

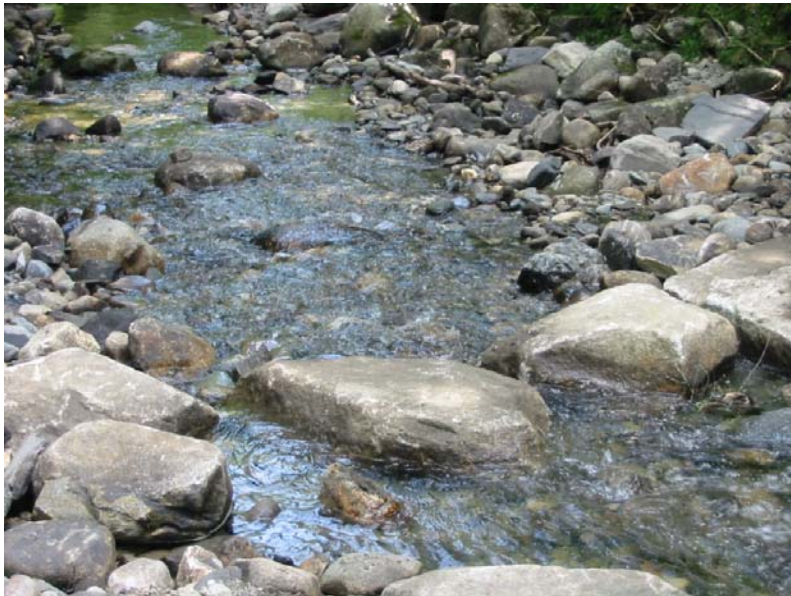
Photograph looking downstream over the rock weir with fish passage channels and the roughened channel at Culvert #2 (Middle) taken on August 13, 2010 during low flow.

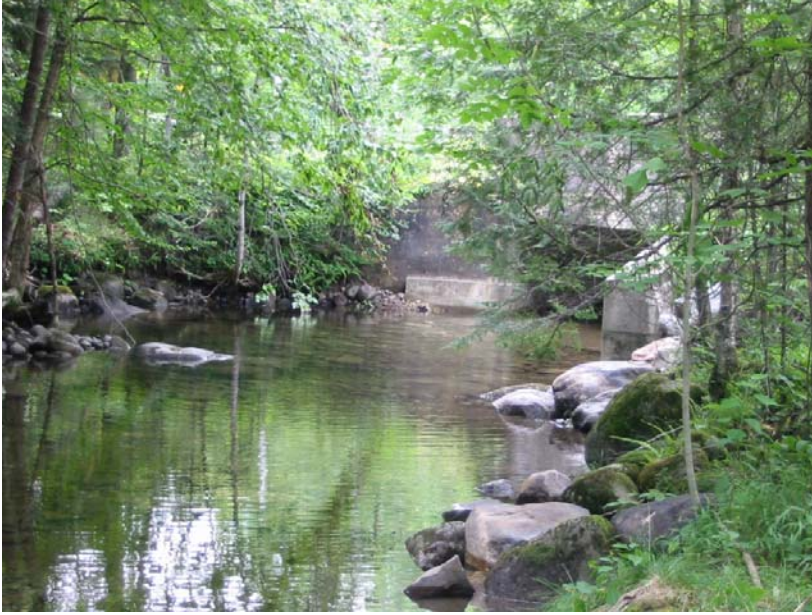
Photograph looking upstream at the backwatered channel at Culvert #2 (Middle) taken on August 13, 2010 during low flow.

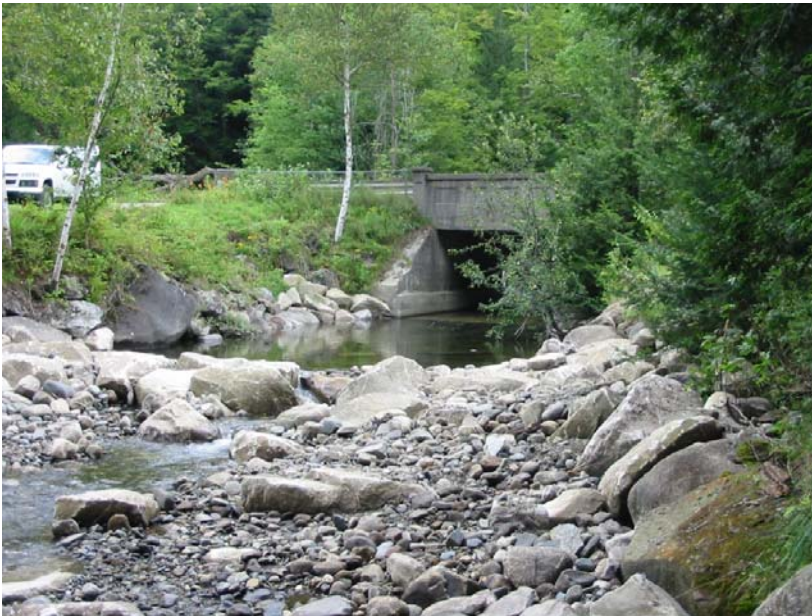
Photograph looking upstream over the rock weir with fish passage channel and backwatered Culvert #3 (Lower) taken on August 13, 2010 during low flow.

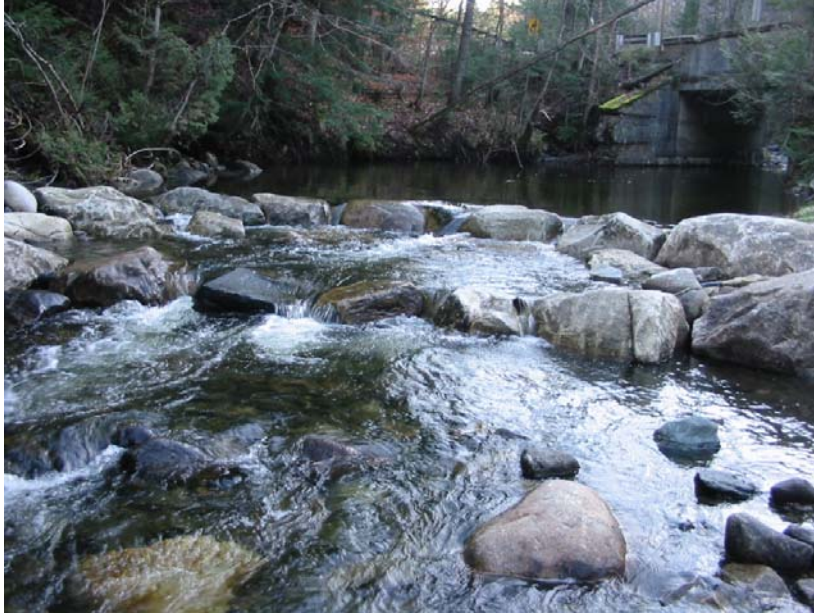
Photograph looking upstream over the rock weir with fish passage channels and the backwatered Culvert #1 (Upper) taken on November 12, 2010 during moderate flow.

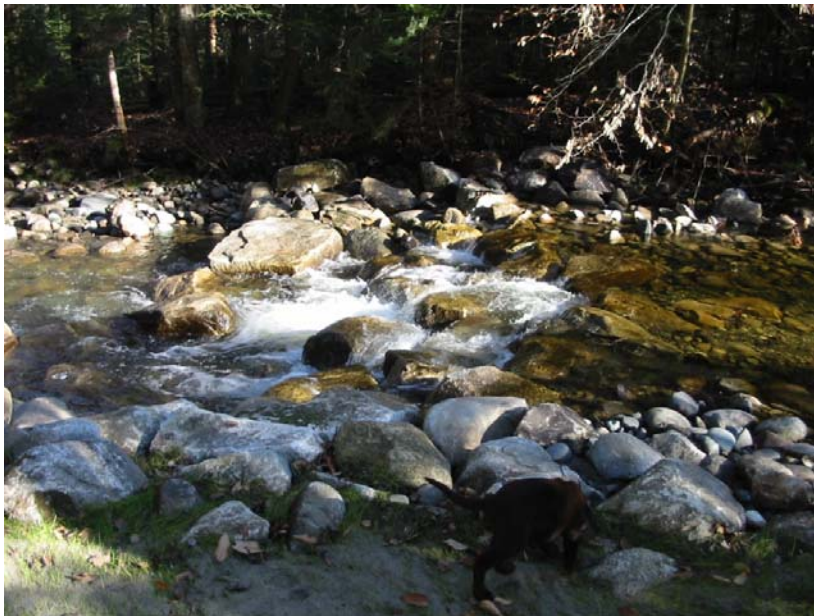
Photograph at the rock weir with fish passage channels from the left bank at Culvert #2 (Middle) taken on November 12, 2010 during moderate flow.

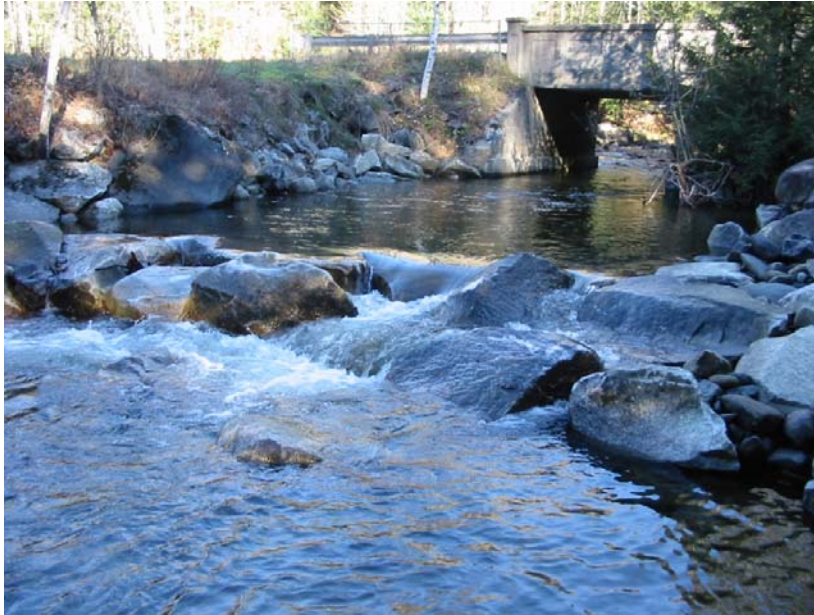
Photograph looking upstream over the rock weir with fish passage channels and backwatered Culvert #3 (Lower) taken on November 12, 2010 during moderate flow.
