Flood Impacts to Wild Trout Populations in Vermont

Vermont Department of Fish and Wildlife

Impacts of Irene on Wild Trout Populations:

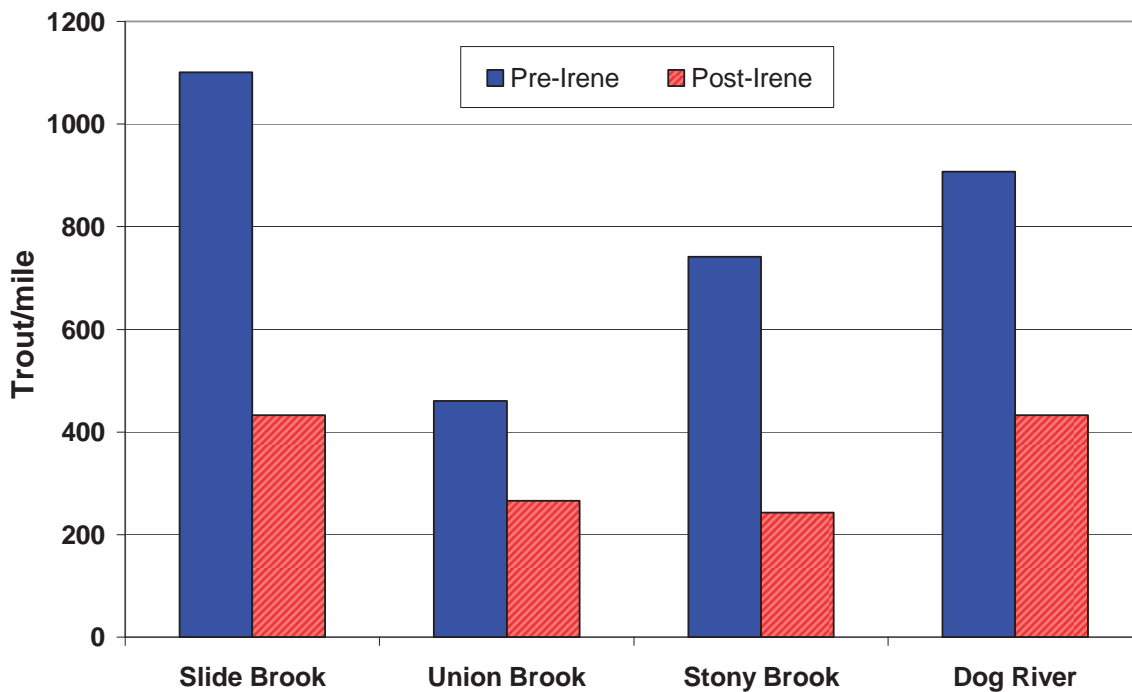
Wild Trout Populations - Before and After Irene Vermont Department of Fish and Wildlife Surveys

Stream surveys conducted in 2011 prior to the Irene flood were repeated in several streams within the Mad River and Dog River watersheds, which had experienced severe flooding. Following the flood, wild trout populations in these streams were reduced to 33-58% of pre-flood levels. Young fish were particularly affected (0-37% of pre-flood levels) while older trout fared better (41-64% of pre-flood levels).

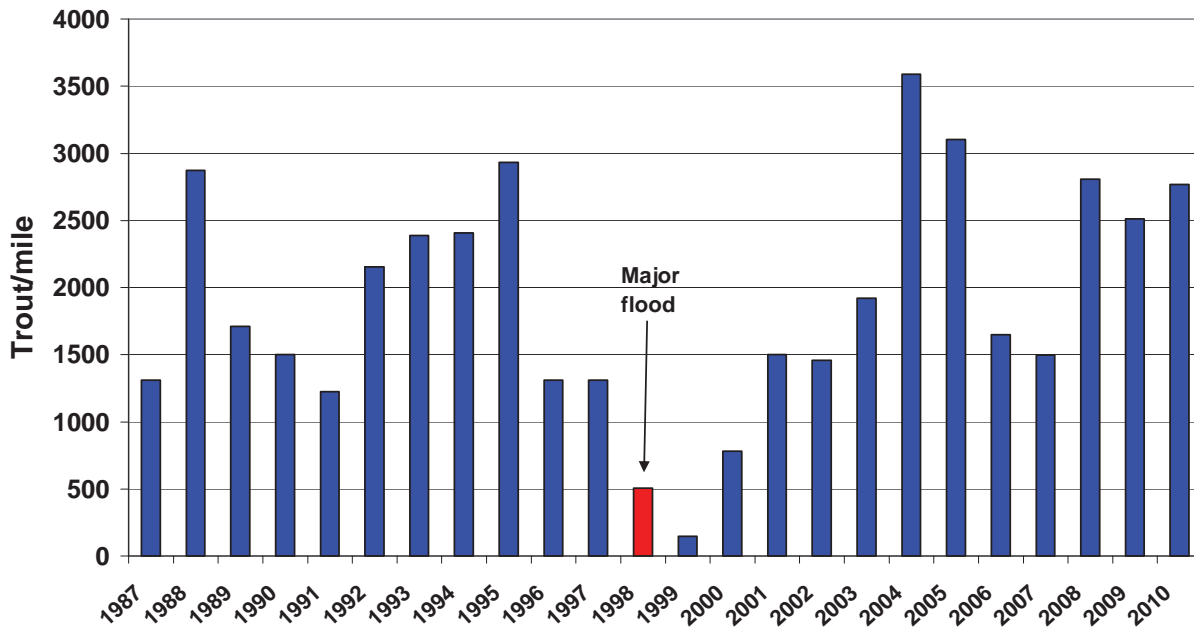
Clay Brook Wild Brook Trout Population Estimates
Vermont Department of Fish and Wildlife Surveys
1987-2010

Long-term monitoring of wild trout populations affected by extreme flood damage provides insight into the future of Vermont’s wild trout populations. In 1998, the Mad River valley and surrounding areas were hit by a devastating flood resulting in severe damage to public and private infrastructure. The wild brook trout population in Clay Brook, a tributary of the Mad River in Warren, was reduced to a fraction of its previous levels. Significant recovery was noted in 2000 and by 2001 the population was within its normal pre-flood range where it remained for the next decade.

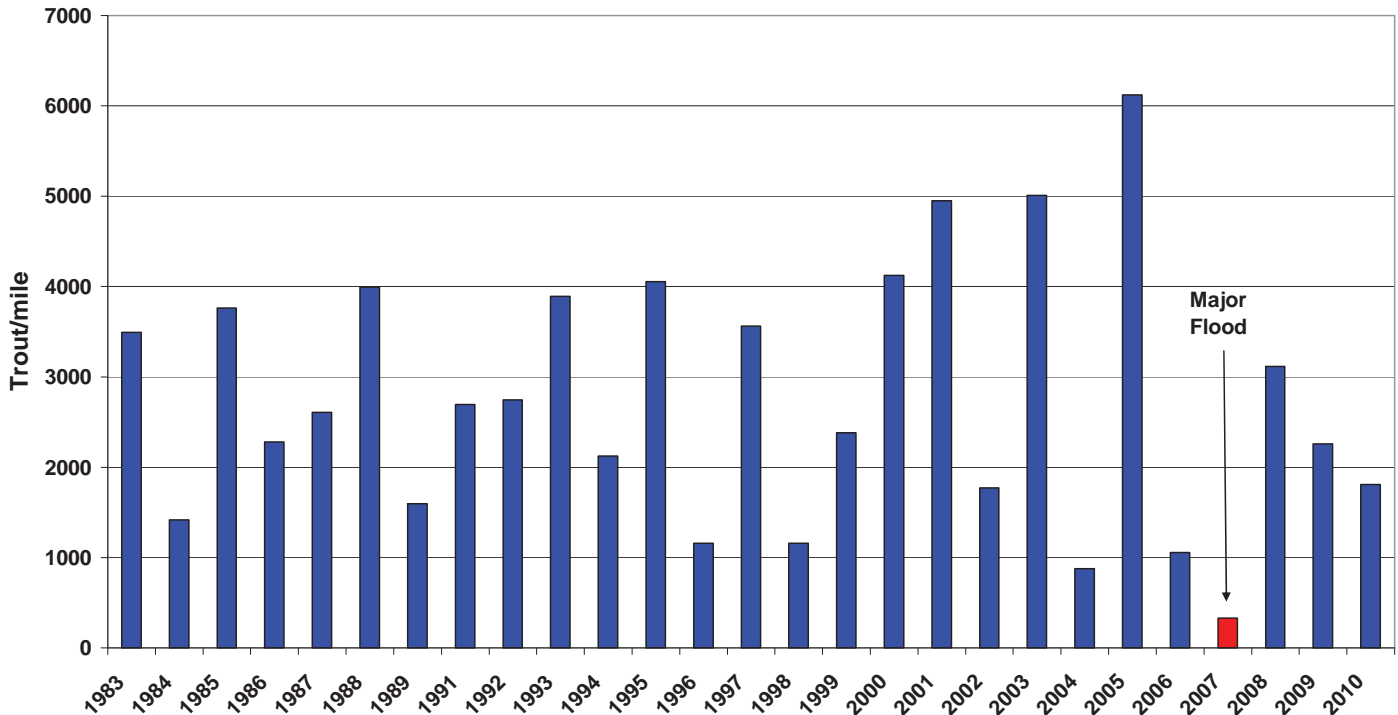
Lilliesville Brook Wild Trout Populations
Vermont Department of Fish and Wildlife Surveys
1983-2010

A similar situation occurred in the White River watershed in 2007, when Lilliesville Brook and nearby tributaries of the White River were severely impacted by flooding. Several bridges, culverts and homes were lost on Lilliesville Brook Road. The wild trout population was reduced to its lowest level recorded in 24 years. However, the following year, the wild trout population rebounded to pre-flood levels and has sustained itself since.

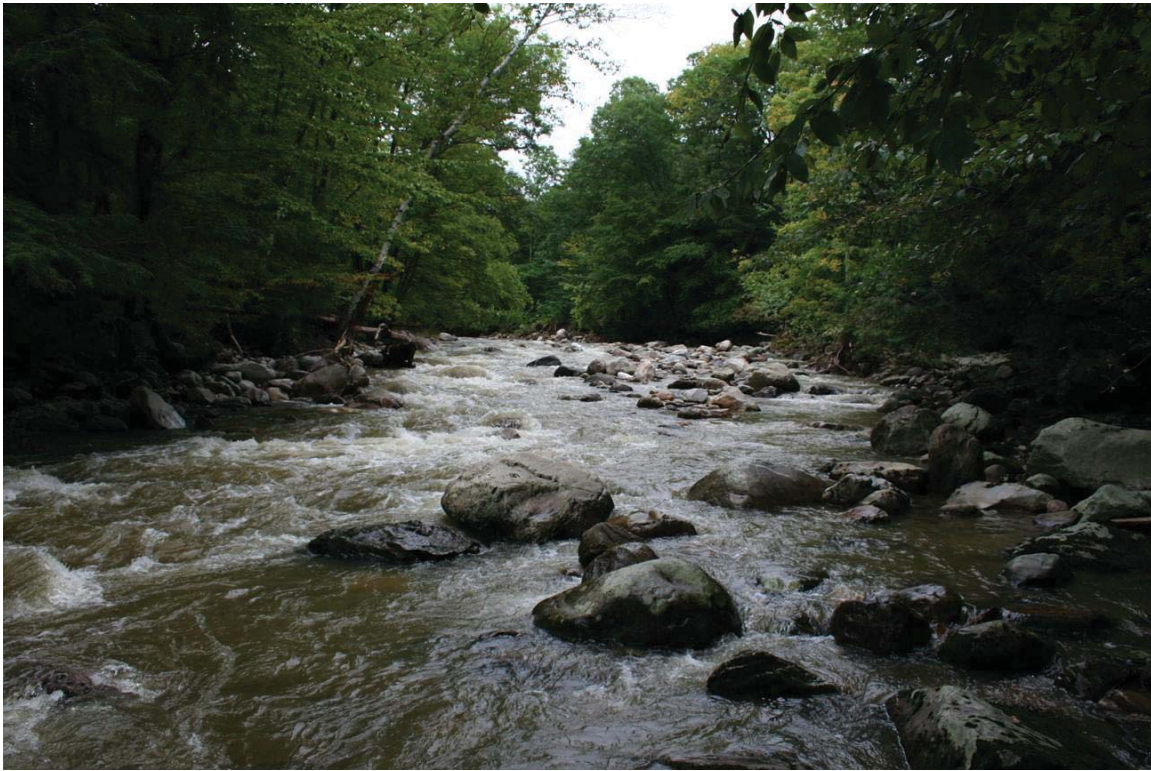
A section of stream with a diversity of natural habitat conditions created by large boulders, fallen trees, cobbles, gravels and forested shoreline.

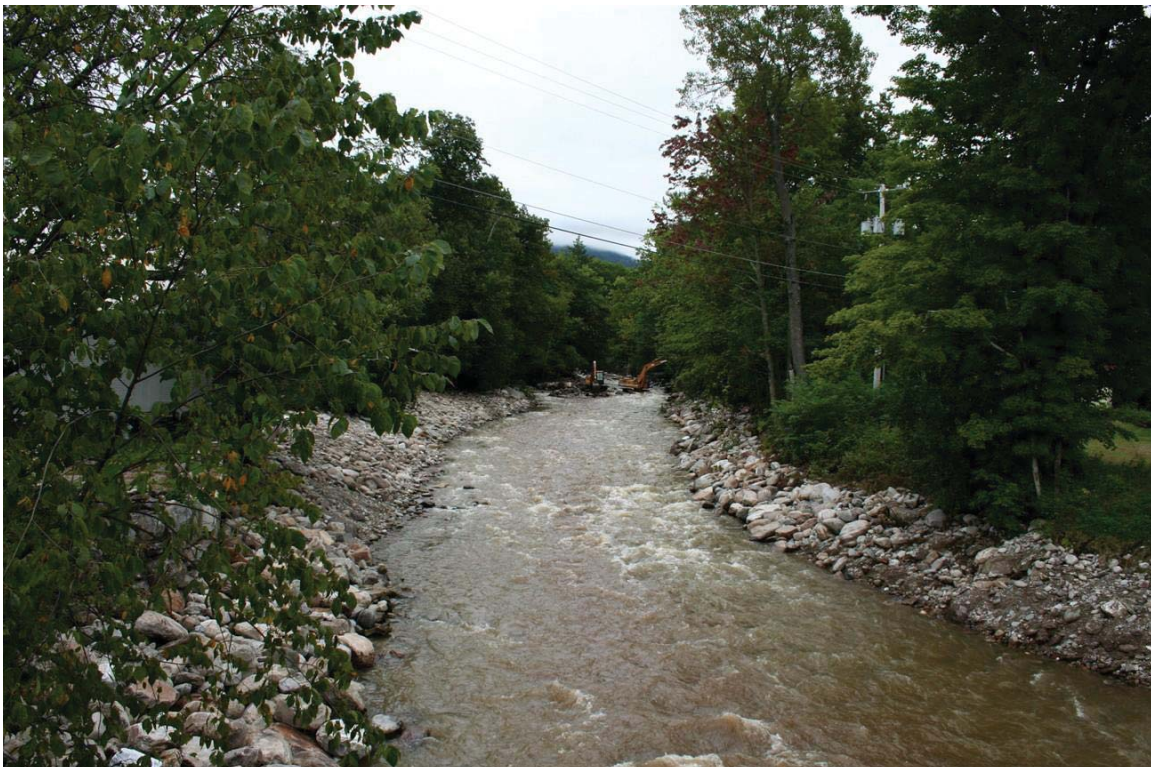
The same stream in a downstream location has been channelized, removing large materials from the channel and lining the streambanks, creating a homogeneous stream channel with poor aquatic habitat value.

Instream flood recovery activities such as channelization, excessive streambed excavation and large scale natural wood removal greatly reduces the quality and diversity of aquatic habitats necessary to sustain fish and other aquatic populations. Different species and lifestages require a variety of habitat conditions to complete their life cycle. When aquatic habitats are degraded and homogenized, it requires many years or decades to recover, as these materials (cobbles, boulders, trees, etc.) must move in from upstream areas during high flows, and the river must slowly recreate pools, bends and other habitat features.

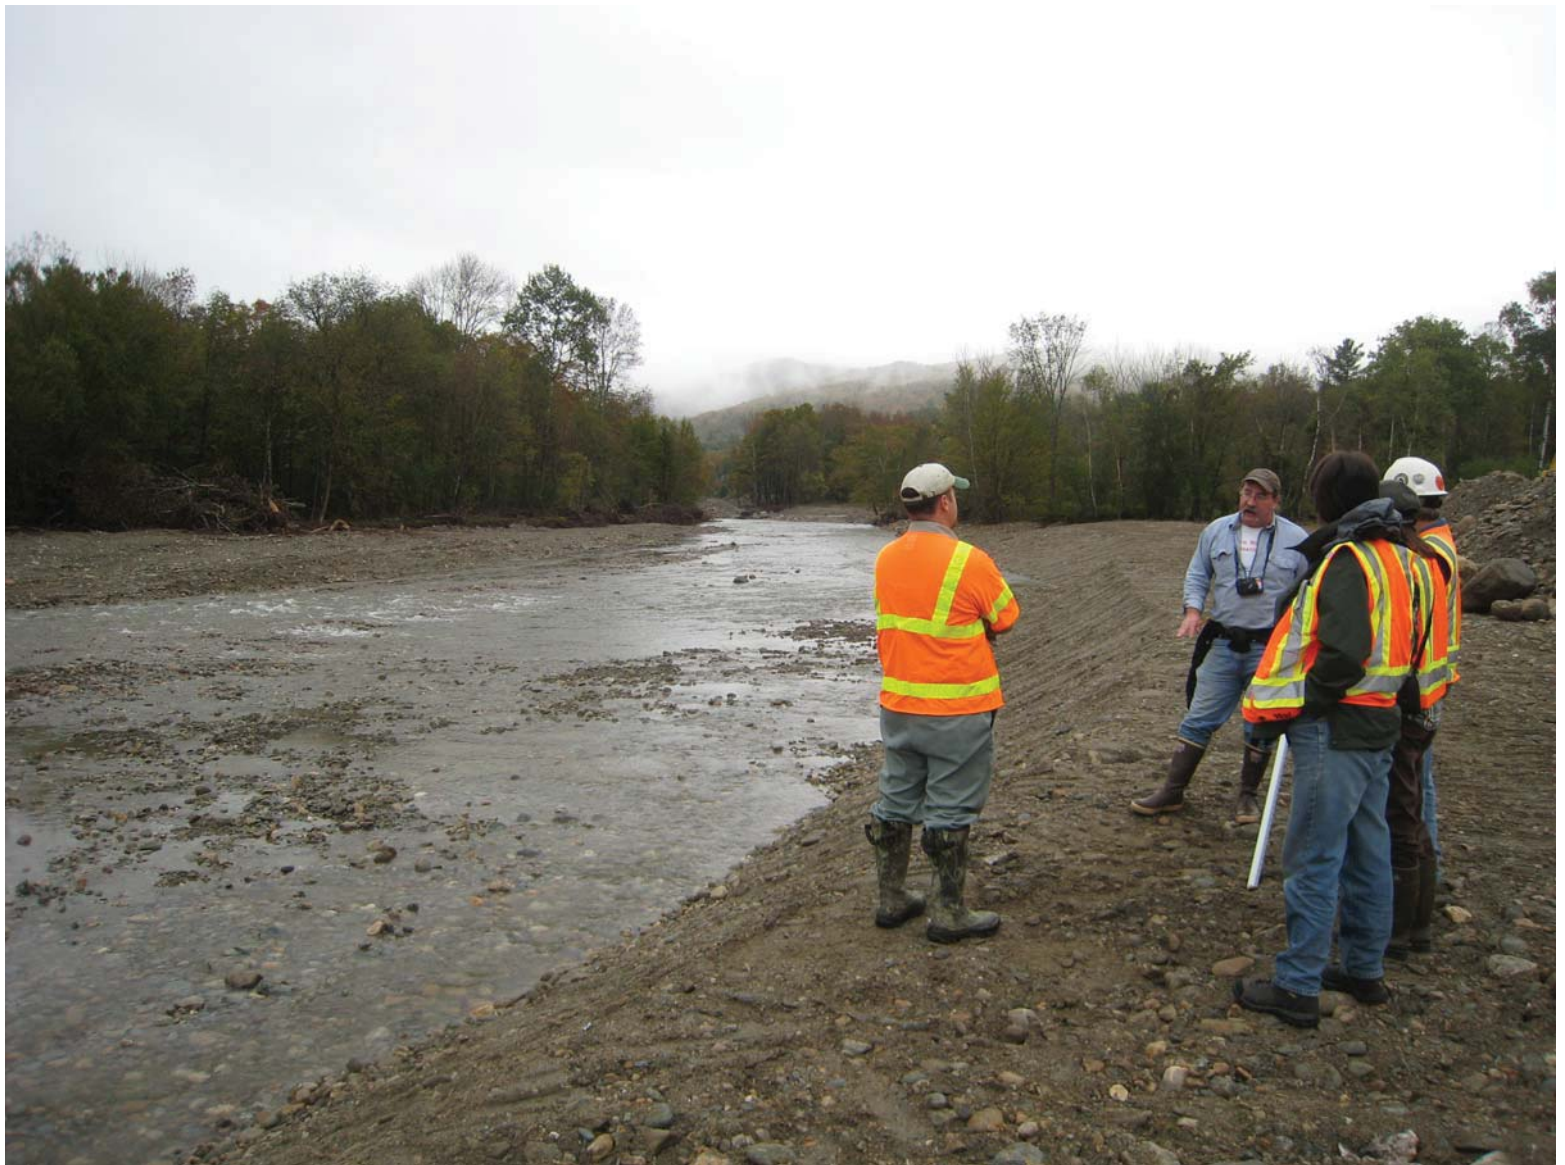
*West Branch of the White River following post-flood channelization activities.
This over-widened, shallow, featureless streambed provides very poor aquatic habitat and will
take many years, if not decades, to recover.*
