VERMONT STREAM CROSSING HANDBOOK

STREAM CROSSING DESIGN CONCEPTS AND CONSIDERATIONS FOR AQUATIC ORGANISM PASSAGE (AOP)

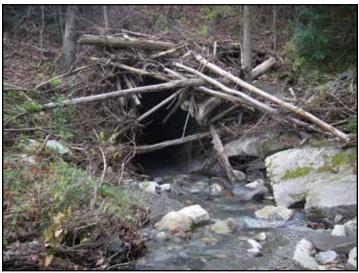
Debris clogging.

Crossings should be large enough to pass fish, wildlife, debris and floods. The most common cause of culvert failures is when undersized culverts plug with debris during floods. When culverts plug, the culvert and road fill act as a dam, ponding water upstream. When water overtops the road, it erodes a new channel through or along the roadway.

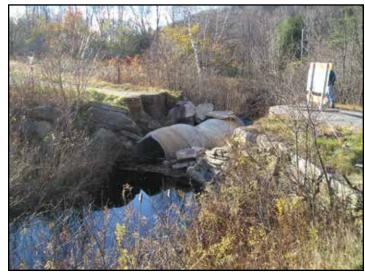
Roadway failure.

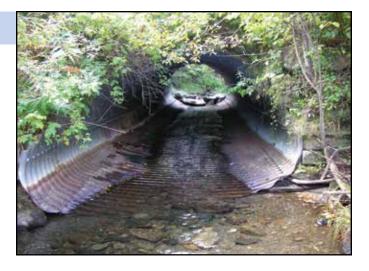
Shallow crossings are too high compared to the natural stream channel. The floor of the culvert is exposed and a natural streambed cannot form. As a result, water depths are commonly too shallow for many organisms to pass through them. Crossings should have a natural streambed with substrate and water depths that are similar to the surrounding stream.

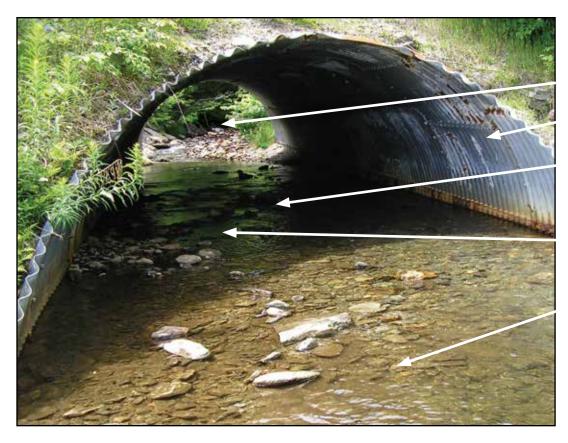
A WELL DESIGNED CROSSING

Large size suitable for handling flood flows

Open arch design

Does not constrict the stream channel bankfull width

Natural substrates create good conditions for stream dwelling animals

Water depth and velocities match stream conditions
