# Phase 1 Geomorphic Assessment of the Batten Kill Main-Stem and Major Tributaries

February 6, 2004

Shane Jaquith & Mike Kline, VT DEC River Management Program

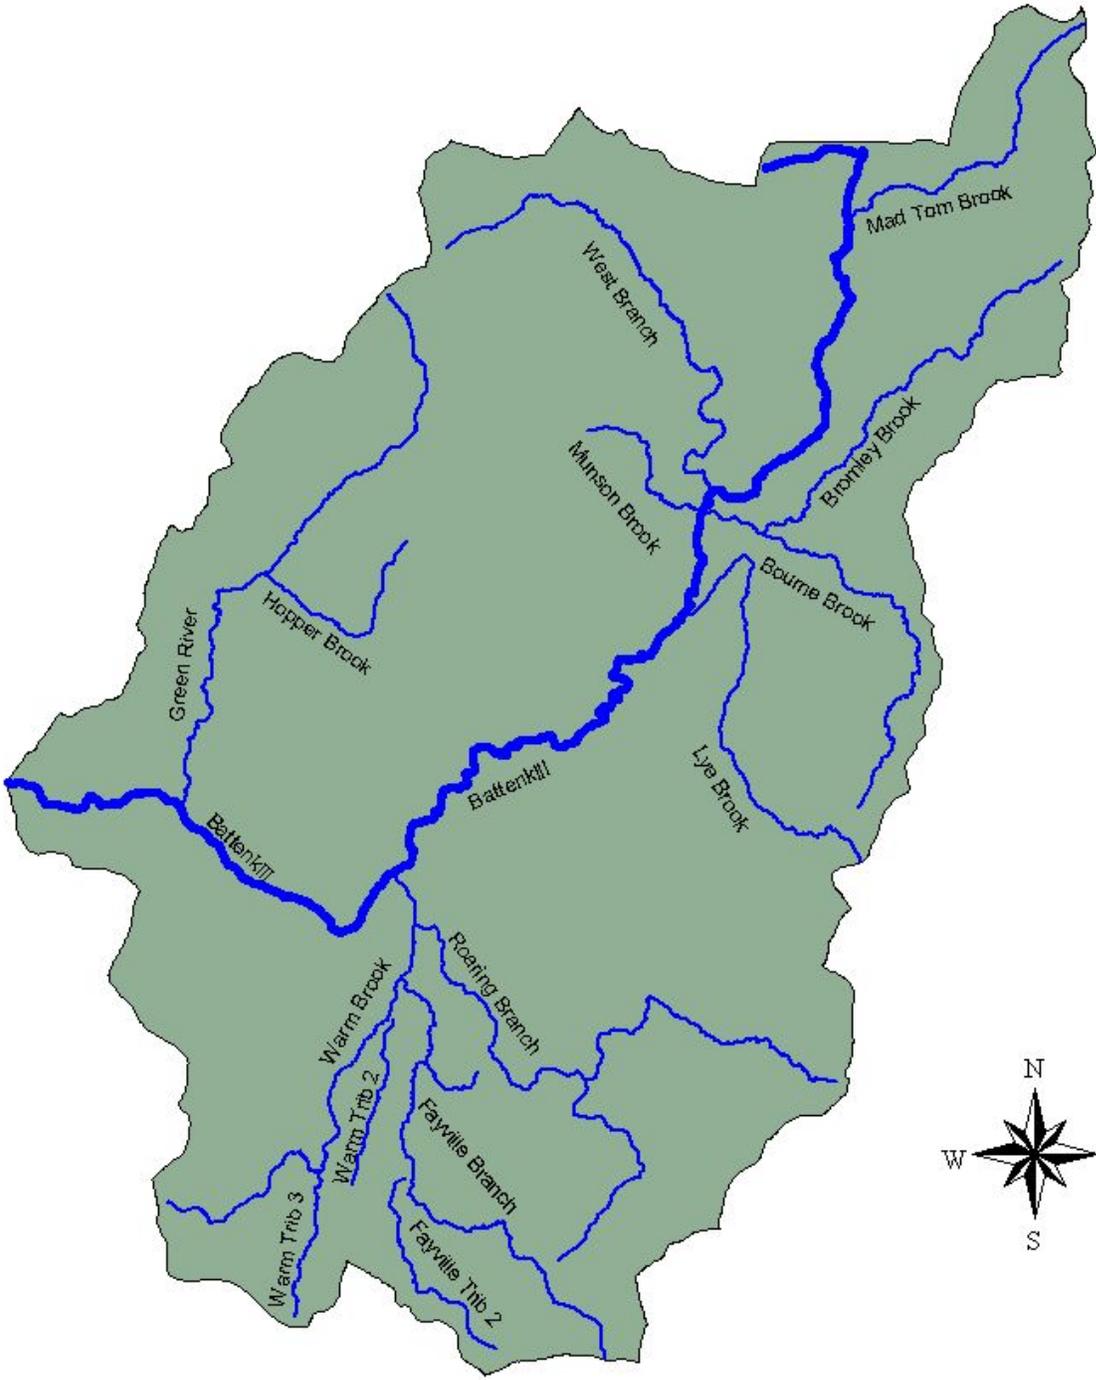
Figure 1 Phase 1 Assessment Streams

Phase 1 assessment was conducted on the entire main-stems of the Batten Kill, seven primary tributaries (direct tributaries to the main-stem), and eight secondary tributaries (see Figure 1). The seven primary tributaries chosen for assessment included all major tributaries. Major tributaries are defined in the Vermont ANR Geomorphic Assessment Protocols as tributaries that constitute 10 % or more of the watershed area at their confluence with the main-stem. The eight secondary tributaries selected for assessment include streams that after preliminary investigation were suspected of being impacted by significant land and channel management activities.

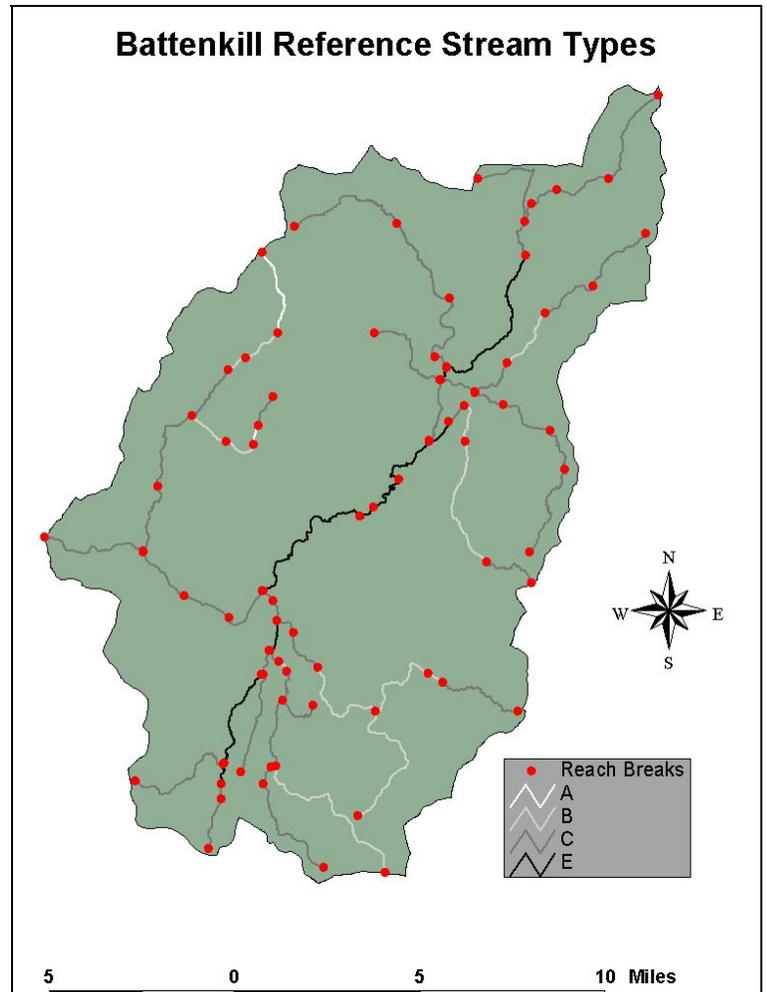
Figure 2 Reference stream types of the Batten Kill watershed as determined by P1 assessment.

Through the assessment of stream and valley characteristics including valley confinement and slope, reference stream types were assigned to each geomorphic reach. Reference stream types are assigned to describe stream channel forms and processes that would exist in the absence of human-related changes to the channel, floodplain, and/or watershed. Phase 1 assessment utilizes a stream type classification system that is based on two classification schemes including Rosgen, 1996 and Montgomery and Buffington, 1996. Figure 2 shows the predicted reference stream type of each assessed reach. A majority of the assessed reaches are low to very low gradient, with broad valleys and flow through alluvial material (Stream Types C and E). Such reaches typically have riffle pool or ripple dune bed forms that play an important role as habitat for aquatic organisms. Habitat in the steeper more confined reaches (Types A and B) is provided by step-pool bed forms that are typical of such reaches. See Report 2 of Appendix A for a complete listing of reference stream and valley types for each reach.

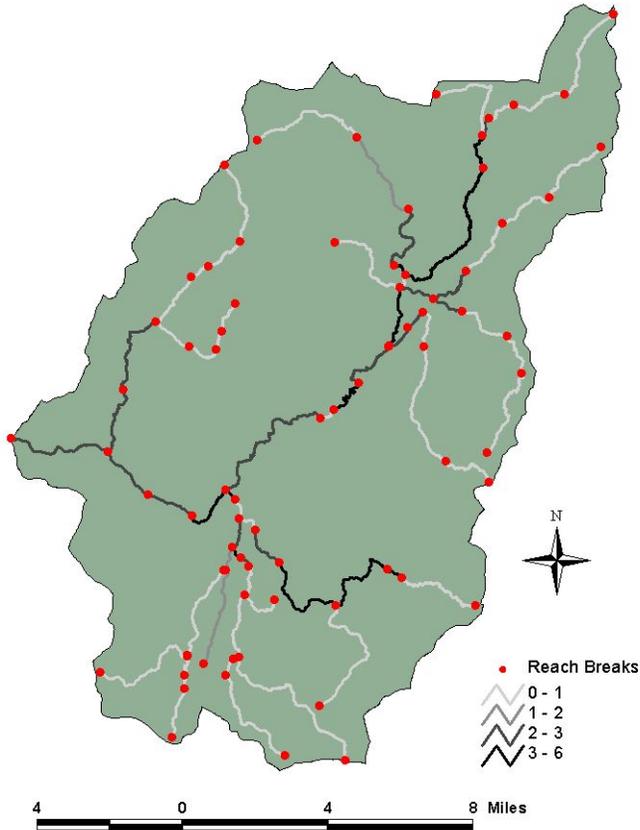
Figure 3 Categorical channel modification impact scores.

The cumulative impact score for the entire channel modification category of geomorphic stressors, was derived for each reach by summing the dredging, straightening, windrowing, armoring stream crossing, and flow regulation impact scores (shown in Figure 3). Possible channel modification impact scores range from 0 – 10. See Phase 1 Summary of Categorical Impacts of Appendix A for a reach by reach listing of cumulative channel modification impact scores. Categorical channel modification impact scores were then summed for each stream and normalized by the number of reaches per stream. These scores are listed in Table 4. The table shows that the Main stem, the Roaring Branch and the West Branch are the streams most impacted by channel modification impacts.

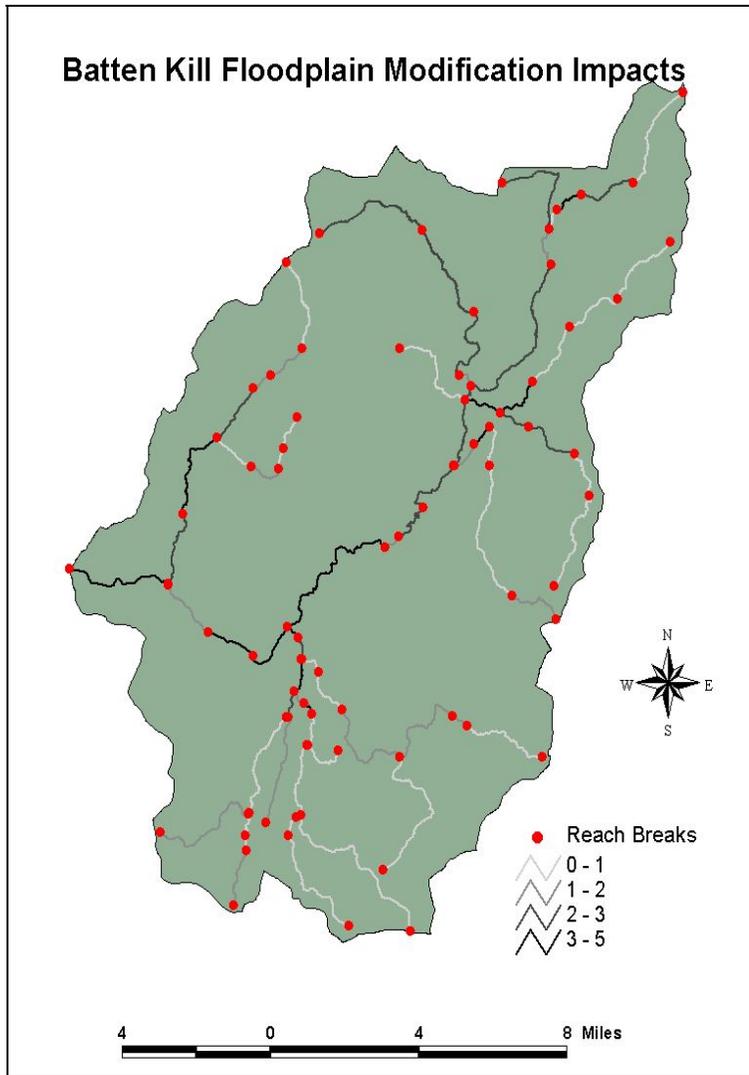
**Figure 4 Floodplain modification impact scores.**

Cumulative floodplain impact scores were derived by compiling impact scores for berms, roads, corridor development, channel migration rates, extent of depositional features and the meander geometry of the channel. Possible scores, ranging from 0 – 12, are shown in Figure 4. See Phase 1 Summary of Categorical Impacts of Appendix A for a reach by reach listing of cumulative floodplain impact scores. Reaches with the highest cumulative floodplain modification impact scores are listed in Table 8. The table shows that the highest floodplain modification impact scores are on reaches of the Bourne Brook, Main stem, the Roaring Branch, the Green River, Lye Brook, Warm Brook and Mad Tom Brook. Eight of the twelve listed reaches are C and E type streams. Because these streams are low gradient and flow through erodible material they are particularly sensitive to the increases in stream power that result when flood plain capacity is diminished or altogether removed.

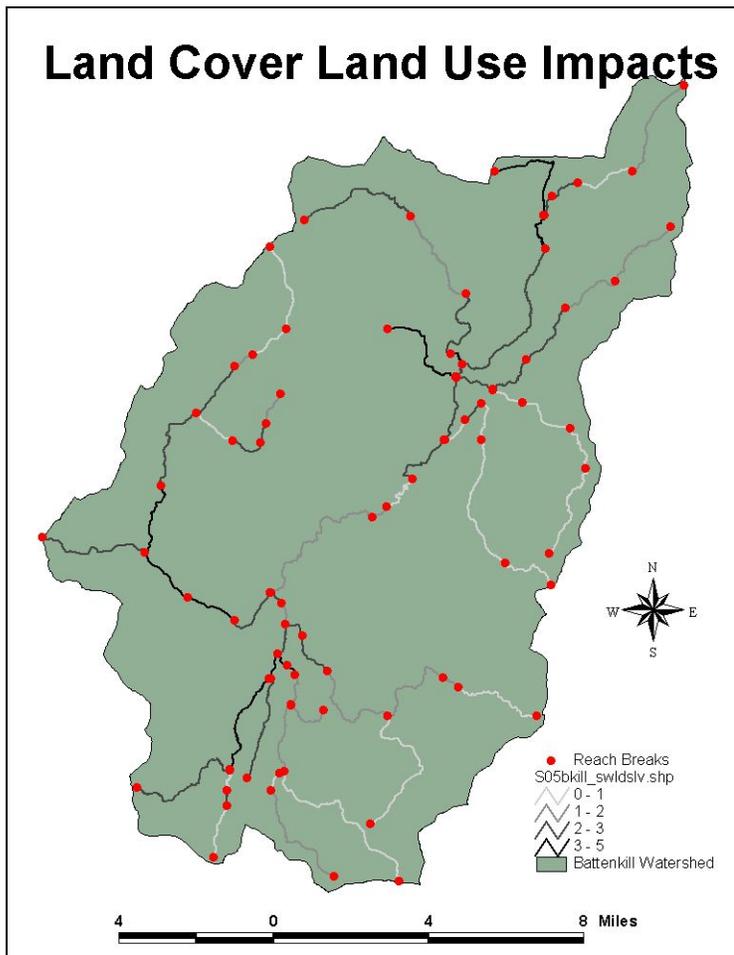
**Figure 5 Categorical land cover / land use impact scores for each reach.**

The categorical land cover / land use impact rating scores which are derived by compiling riparian buffer, watershed and corridor land use / land cover impact scores for each reach are shown in Figure 5. Possible impact scores range from 0-6. See Phase 1 Summary of Categorical Impacts of Appendix A for a reach by reach listing of cumulative land use land cover impact scores. The figure shows that the highest impact scores are on reaches of the Warm brook, Munson brook, the Main stem, the Green river and the West Branch.

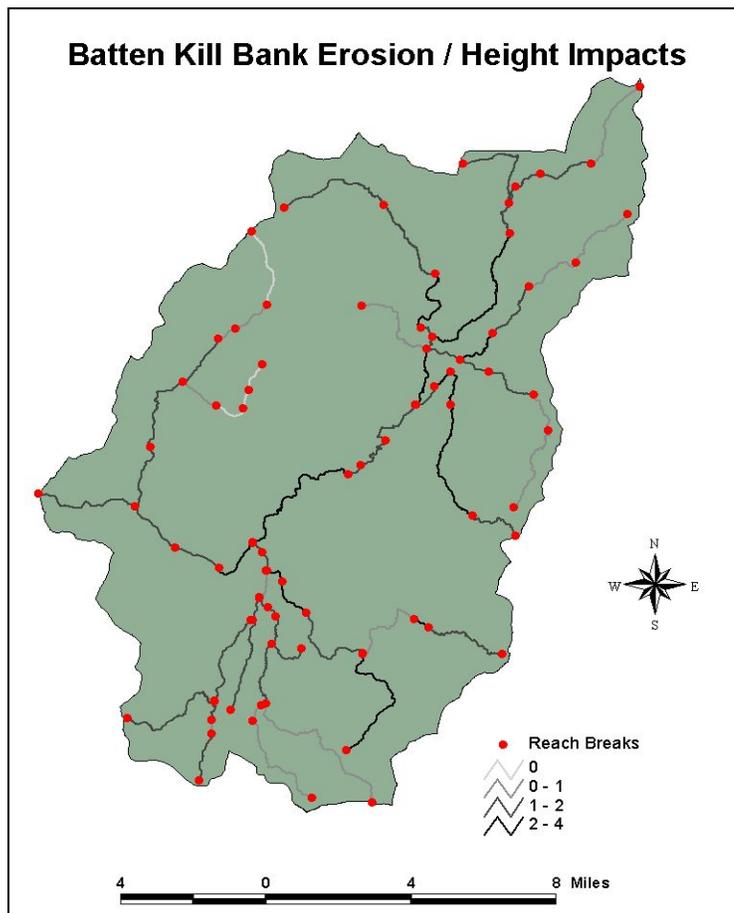
**Figure 6 Bank erosion and bank height impact scores**

Figure 6 shows the bank erosion / bank height impact scores for each assessed reach. Possible scores range from 0-4. For a complete reach by reach listing of bank erosion / bank height impacts see Report 7 of Appendix A.

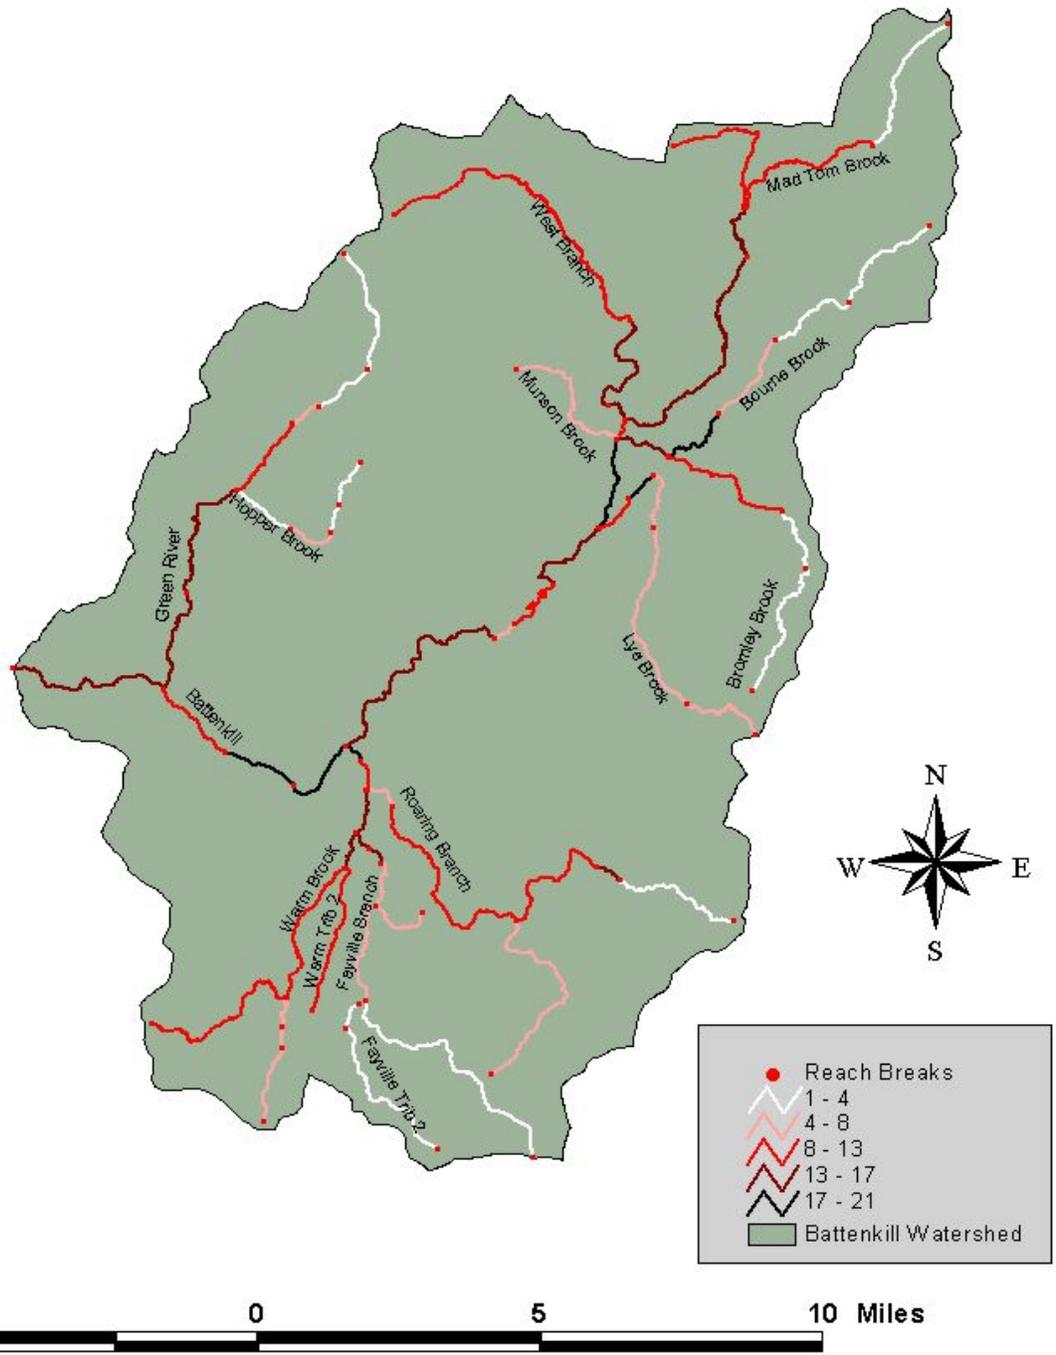
Figure 7 Total impact scores for assessed reaches.

In order to rank the cumulative level of impact to each reach, the impact scores for the parameters listed in Table 15 were totaled for the reach. The reaches with scores of ten or greater are listed in Table 16. Total Impact scores for all reaches are shown in **Error! Reference source not found.** For the purpose of ranking the impacts by stream, the total impact scores were summed and then normalized by the number of reaches contained in each stream (see Table 17). The table shows that those streams with the highest normalized impact scores include the Batten Kill, West Branch, Warm Brook, the Roaring Branch, and Bourne Brook.

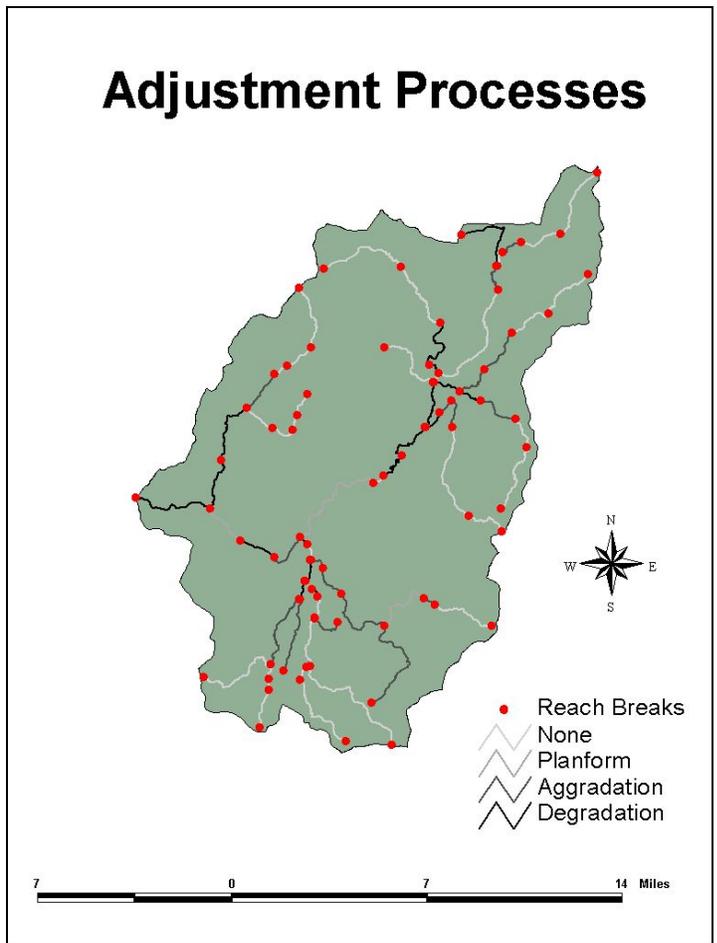
**Figure 8 Reach by reach channel adjustment processes indicated by Phase 1 impact ratings**

Results from analysis of these parameters are shown in Table 18. The historic channel and land management practices in the Batten Kill watershed are likely to have triggered both vertical and lateral channel adjustment. A Phase 1 report uses a data query to generate scores for each adjustment process. While attempting to factor the sequence of vertical and lateral adjustments in the Channel Evolution Model (Figure 15), the query cannot fully capture important temporal and spatial relationships within the watershed and therefore is not able to accurately predict a current adjustment process. While the Adjustment Process Report predicts, based on highest scores, which adjustment process may be ongoing in the reach (Figure 8), the query typically generates high scores for several adjustment processes given the interrelationship of the stressors that initiate channel evolution. With this in mind, the most salient point of the data presented in Table 15 is that of the assessed reaches, 54% are likely to be experiencing or undergoing some channel adjustment process.

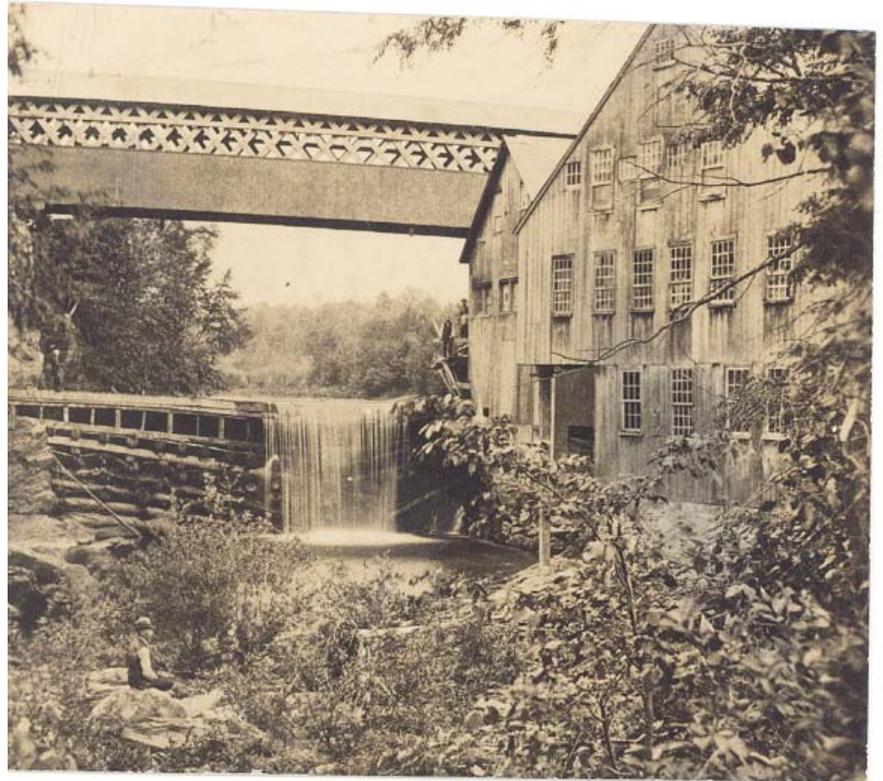
**Figure 9 Chiselville Bridge over Roaring Branch ca 1880's**

The photographs collected document far less forest cover, a higher degree of in-channel modification and adjustment than exist today, and the presence of historic floodplain modifications,. A typical impoundment associated with timber mills is shown in Figure 9. Figure 10 documents that channel modifications were implemented as part of post flood mitigation efforts following the floods of 1973 and 1976. Figure 11 and Figure 12 show an example of the type of channel and floodplain modifications that occurred to accommodate transportation development. See additional photos in Appendix B.

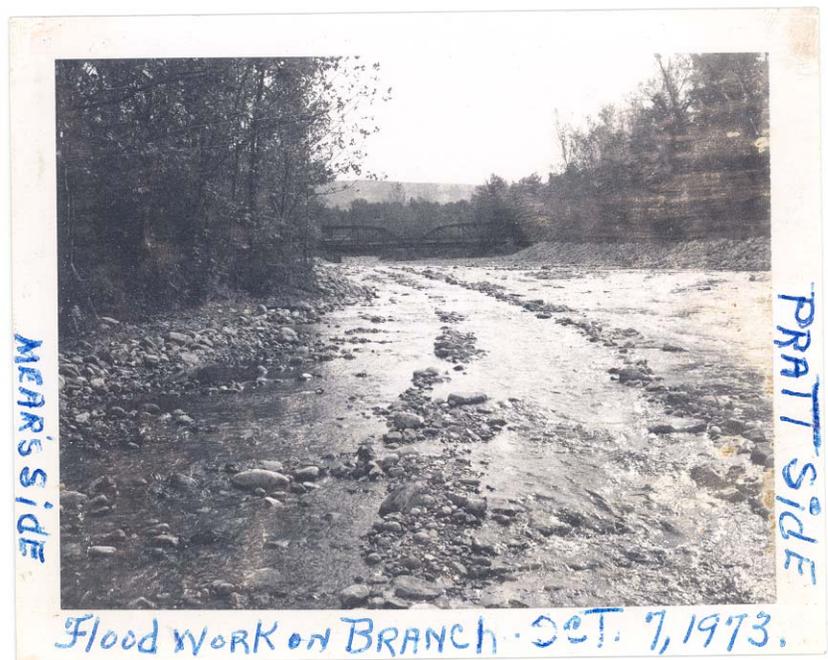
**Figure 10 Roaring Branch post flood channel management, 1973**

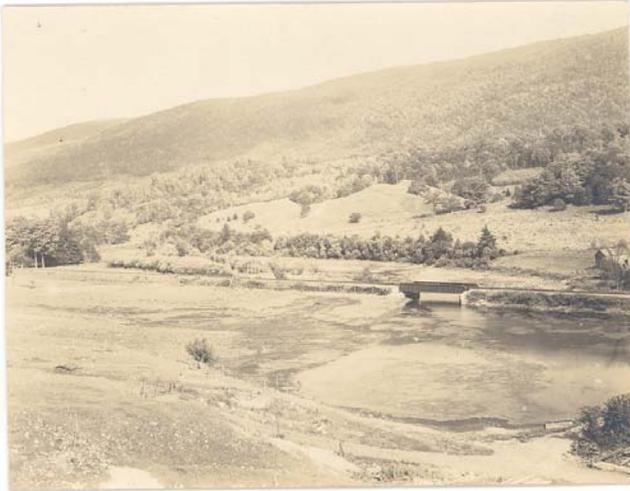
**Figure 11** Historic photo showing modification of floodplain by raised rail bed.

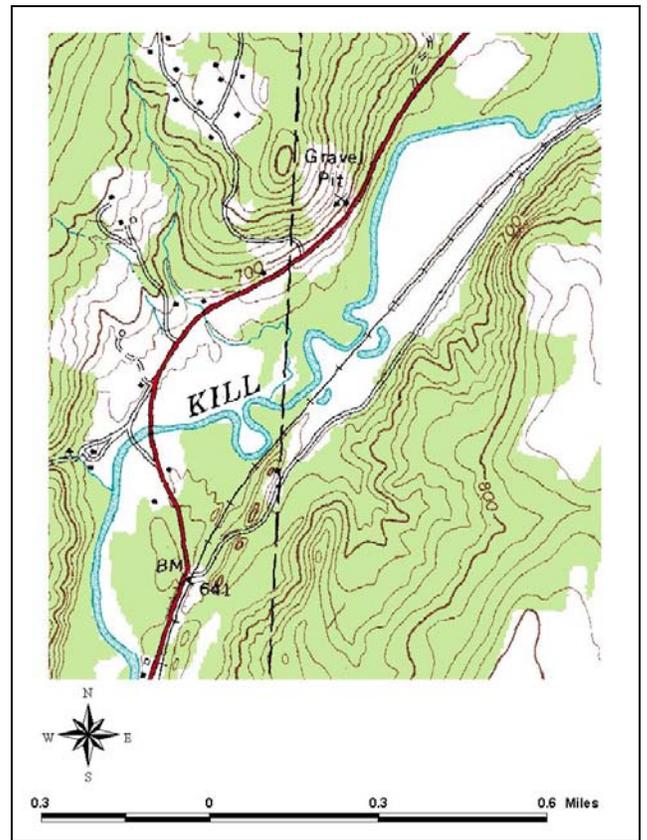
**Figure 12** Mainstem of the Batten Kill modified to accommodate rail.

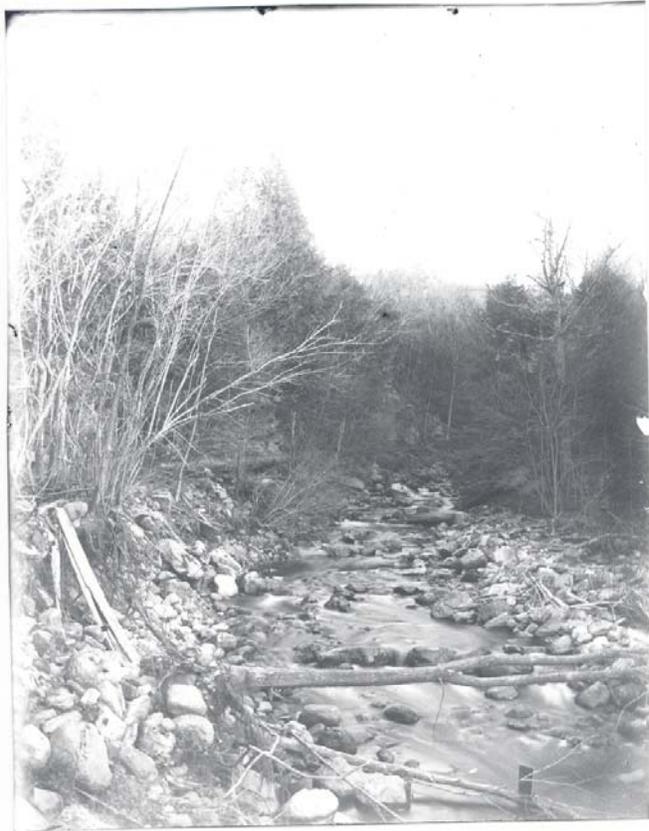
Figure 13 Historic Photo of Lye Brook showing incision.

Channel incision was likely the dominant adjustment process to initially occur following early impacts to the watershed (see Figure 13). As incision progressed, storage of the eroded material took place at lower gradient reaches (see Figure 14 and Figure 15) and a complex series of adjustment processes was set into motion. Channel evolution likely advanced greatly with the energy provided by the floods of the 1970's, however, post flood mitigation works acted to re-establish the incised condition of major tributaries. In the years since the 1970's floods, the occurrence and rate of channel incision is likely to have slowed on most reaches but may still be active at certain locations.

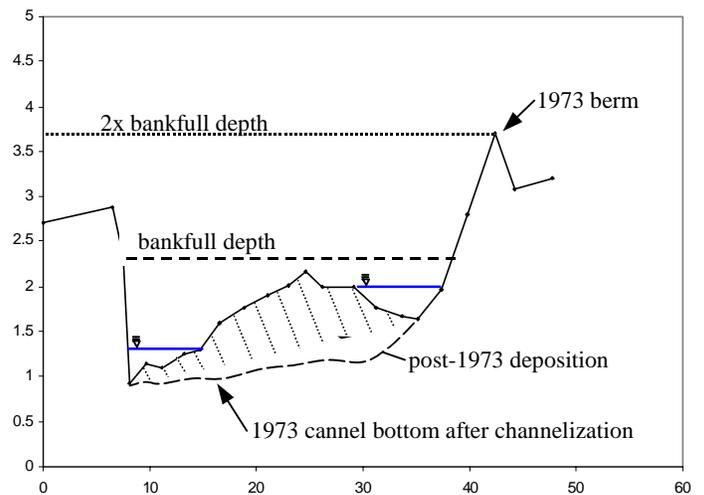
Figure 14 2002 Cross-section of the Roaring Branch where post flood dredging and berming was completed showing 30 years of sediment aggradation in the incised channel (Stage IV of Channel Evolution Process shown in Figure 2).

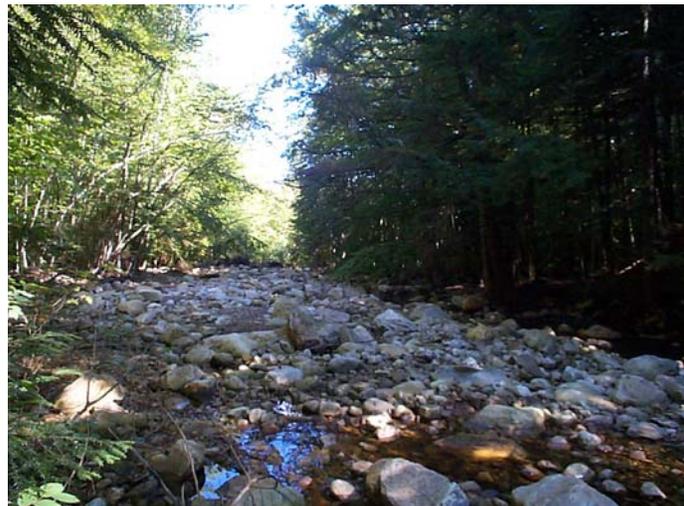
Figure 15 Aggradation filling entire channel on Lye brook

In those reaches where incision has ceased, aggradation and widening may be occurring as the reaches transition into Stage 3 and 4 of the channel evolution model (see Figure 16. Phase 1 and Phase 3 data suggest that the greatest aggradation is occurring at lower gradient reaches of the tributaries, including locations near their mouths and reaches of the main stem above Dufresne Dam. Aggradation is present but not as dramatic on the lower reaches of the main-stem below Reach M09. Main-stem E type reaches do not appear to be aggrading at all. It seems that they are either not receiving excess bed load from the tributaries or they have a enough sediment transport capacity to keep from aggrading.

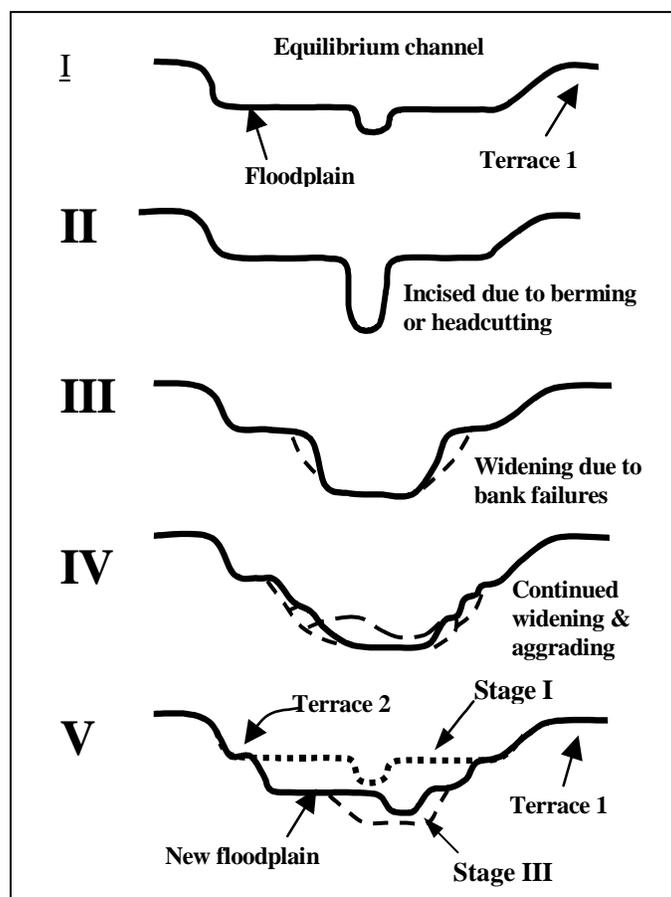
Figure 16 Diagrammatic representation of channel evolution process (Schumm, 1984) ongoing in reaches of the Batten Kill in response to historic watershed, channel, and floodplain modifications.
