GREAT BROOK FISH PASSAGE RESTORATION PROJECT PLAINFIELD, VERMONT

MMI #3846-03

January 4, 2011

Prepared by:
Milone & MacBroom, Inc.
South Burlington, Vermont

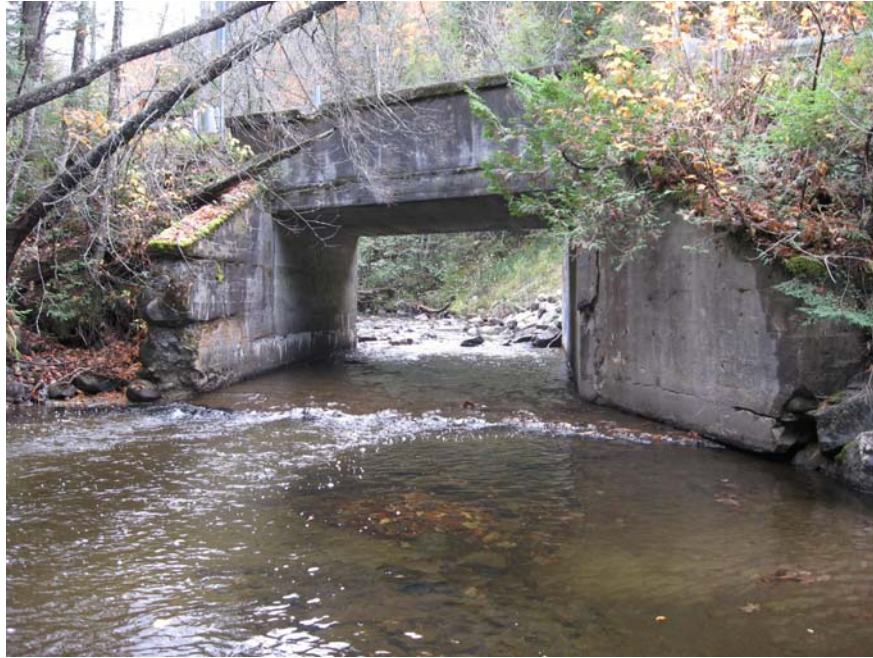
Downstream Face

Culvert #1 at the upstream end of the project (ID 2361, elevation 1,300 feet) had a perched outlet with a downstream plunge pool (Appendix A). The channel makes a sharp bend to the right as it enters the upstream side of the culvert. The left bank is armored with riprap to reduce erosion near the structure. This culvert has some serious structural deficiencies including cracking and dislocated concrete on the right downstream wingwall and the downstream concrete apron. The structure appears to be controlling the grade of the channel as the degree of channel incision appears to be a bit higher on the downstream side of the structure.

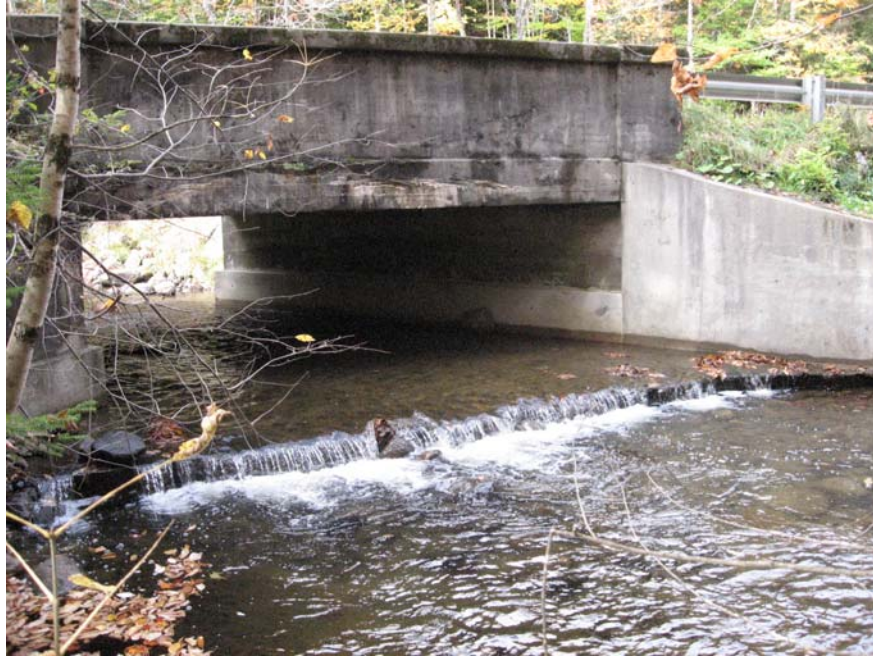
Downstream Face

Culvert #2 (ID 2375, elevation 1,240 feet) had a downstream standing wave indicative of a submerged outlet drop and a plunge pool (Appendix B). Wingwalls at 45 degrees guide water in and out of the structure. Riprap is located on the outside bend as the channel approaches the structure on the upstream side. A small tributary joins Great Brook on the right bank immediately downstream of the structure. The structure appears to be in good condition.

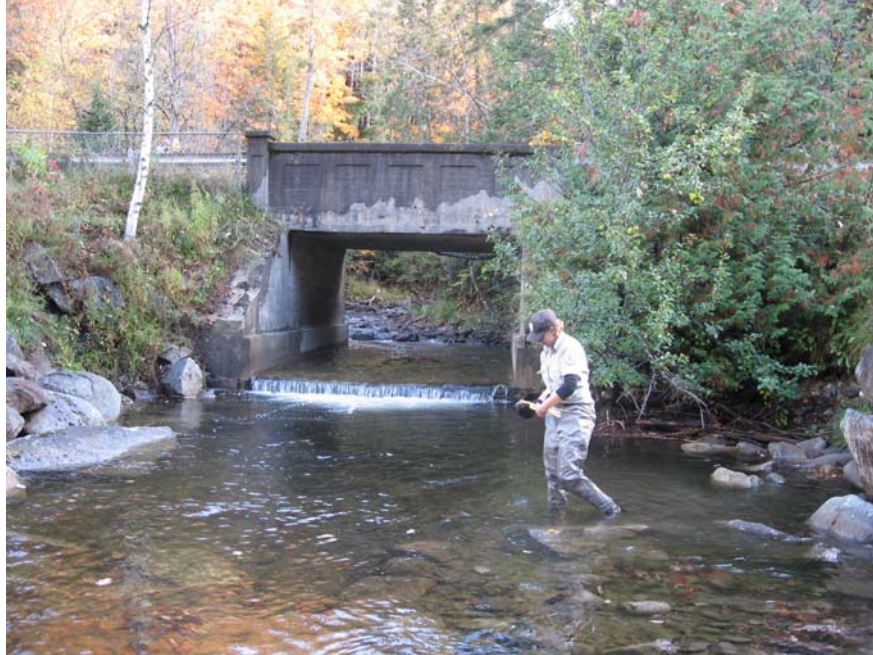
Downstream Face

Culvert #3 (ID 2381, elevation 1,220 feet) located at the downstream end of the project site had an outlet drop associated with the concrete bottom of the box culvert with a downstream plunge pool (Appendix C). The banks were armored with riprap downstream of the structure as the brook flows next to a house before making a bend right along a natural wall of bedrock outcrop. The channel appeared a bit more incised on the downstream side of the structure than upstream, which is common for perched and undersized concrete structures that can act as grade control. Wingwalls at approximately 45 degrees direct flow into the structure, and wingwalls parallel to the flow guide flow out of the structure. The box culvert did not appear to have serious structural deficiencies.
